# **RAPID CLAY DEWATERING PHASE II: FIELD-SCALE TESTS**

*Prepared by*  
Argila Enterprises, Inc.

December 2001

FINAL REPORT

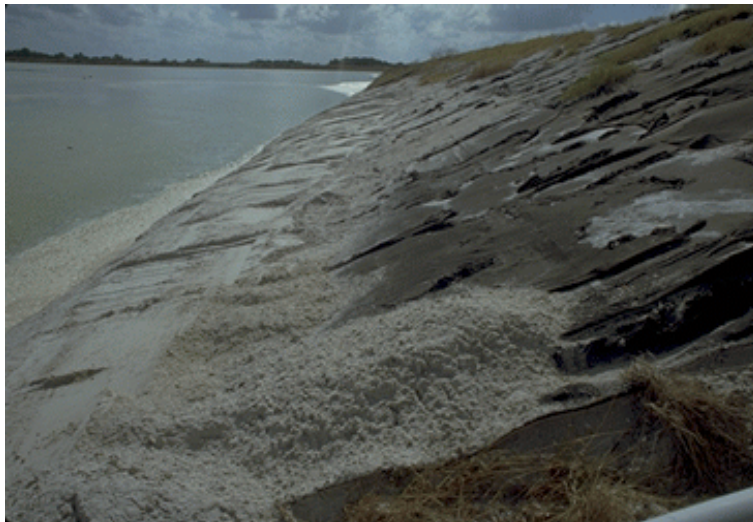
The plastic sheeting-and-nail combination was found to be not well-resistant to wind, as the sheet tended to tear at the nails. (Plastic sheeting is commonly used to protect excavation slopes on construction sites, but the sheet is held down with sandbags.) Heroic efforts were made to hold the plastic sheeting together with duct tape. However, ultraviolet degradation occurred very rapidly and the sheeting virtually disappeared. Consequently, CF personnel placed additional tailings sand on the toe drain a second time, just before it was submerged by the rising pond water, and that sufficed: see Figure 10.

**Figure 10. Southern Geodrain Test Section: Additional Tailings Sand Placed on Toe Drain (Second Time).**  
Nov 19, 1999;  $t = +207$  days; Pond Level = 132.5 ft msl  
[12/16/99: 23]

All of these problems were due to the constraint of installing the toe drain on the slope of the embankment. For future installations, it is recommended that the toe drain either be installed on a bench on the embankment, or at the toe of the slope. This will greatly simplify placing tailings sand with heavy equipment, and, thus, a sufficient volume can be placed which will resist rainfall erosion.

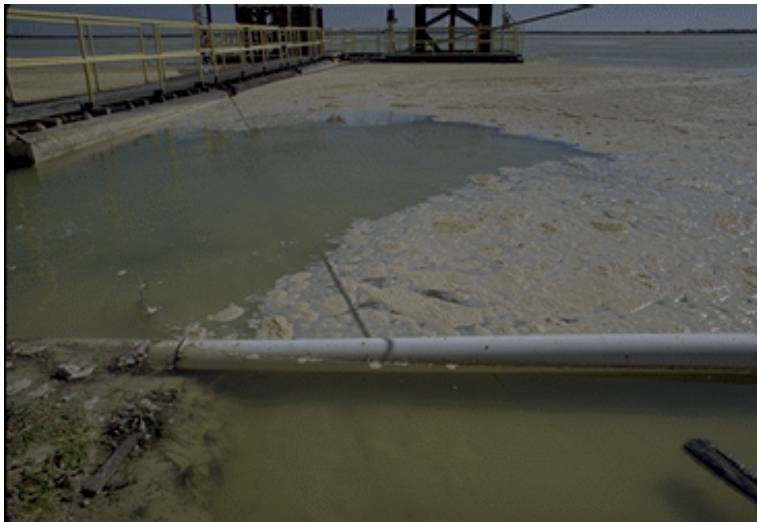
In order to convey the water from the toe drain in the southern geodrain test section to the spillway, it was necessary to assemble a 6-inch diameter PVC (non-perforated) pipe running north, longitudinally along the embankment, and under the catwalk: see Figure 12. This pipeline was held to the embankment with the same anchors that were used with the toe drains. Unfortunately, when the pond water rose, these anchors were found to be insufficient to resist the buoyancy of the pipeline and it floated: see Figure 13. It is believed that this pipeline failed, as water was never observed to flow from the southern test section into the spillway.

**Figure 13. Longitudinal Conveyance Pipeline Floating Free from Anchors.**  
**Feb 16, 2000; t = +296 days; Pond Level = 134.5 ft msl**  
**[03/15/00: 15]**

Consequently, for future installations, it is recommended that longitudinal conveyance pipelines be buried a sufficient depth to resist buoyant uplift. As with the toe drain, this is most conveniently done either on a bench, or at the toe of the embankment slope.

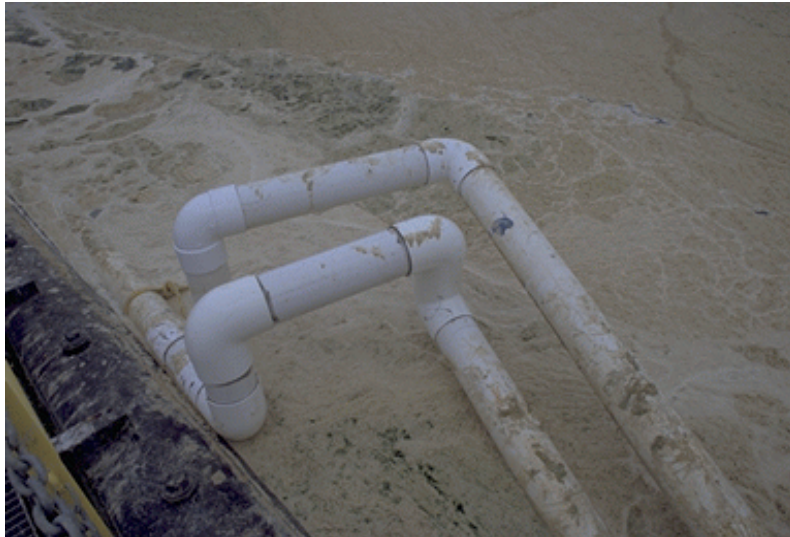
Fortunately, as the pond level slowly declined, the lateral pipeline was “caught” by the catwalk and the repaired elbow was dragged downward, thereby allowing the northern geodrain to continue to flow.

**Figure 19. Repaired Elbows at Lateral Pipeline Joints.**  
Nov 24, 1999; t = +212 days; Pond Level = 132.5 ft msl  
[12/27/99: 7]

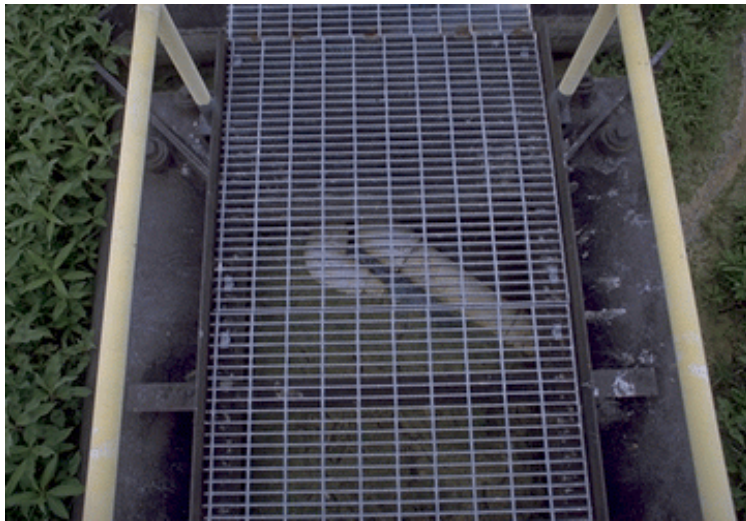
**Figure 20. Repaired Elbows under Catwalk.**  
May 29, 2001; t = +773 days; Pond Level = 135.8 ft msl  
[07/20/01: 5]

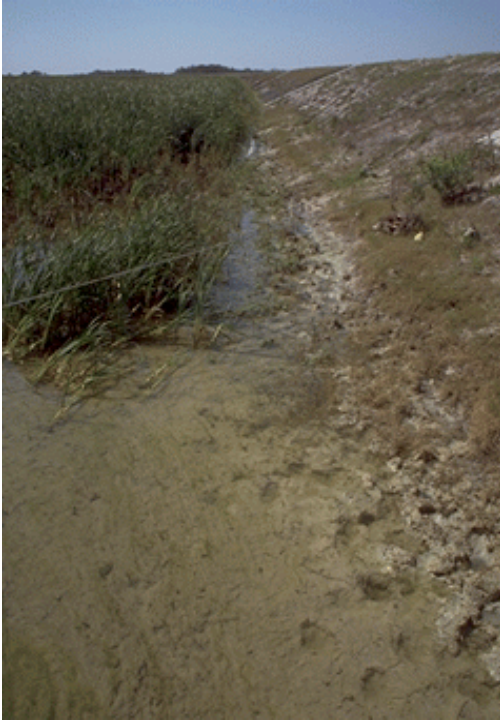
At that time, the clay was bare. As the clay became vegetated, it was noticed that the vegetation in front of the northern geodrain looked “different”; compare Figures 23(ii) and 26(u), both taken on March 23, 2001. At the last site visit on July 3, 2001, it was observed that the vegetation in front of the northern geodrain consisted of: A strip of low grass next to the geodrain, about 5 feet wide; a strip of medium height herbaceous species, about 5 feet wide; and tall cattails beyond. The herbaceous strip did not occur south of the catwalk, nor north of the northern geodrain test section: compare Figures 23(mm) and 26(x).

**Figure 26(u).** Mar 23, 2001; t = +697 days  
Pond Level = 136.0 ft msl [03/30/01: 29]

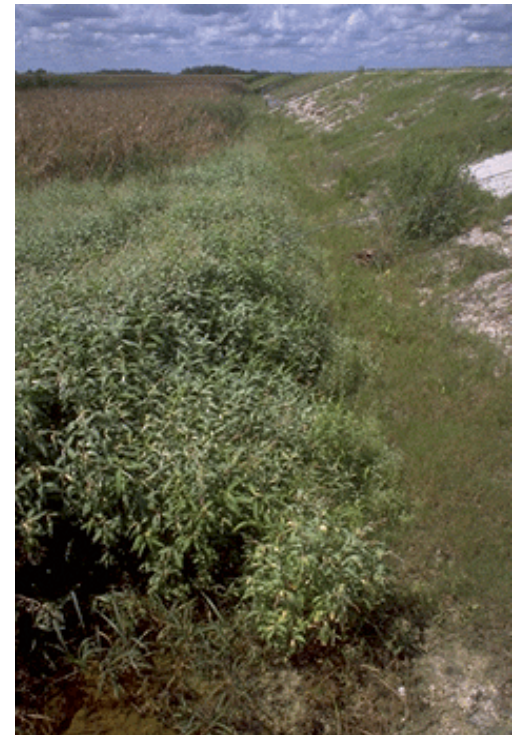
**Figure 26(x).** Jul 03, 2001; t = +799 days  
Pond Level = 135.5 ft msl [07/31/01: 9]
