# **RAPID CLAY DEWATERING PHASE II: FIELD-SCALE TESTS**

*Prepared by*  
Argila Enterprises, Inc.

December 2001

FINAL REPORT

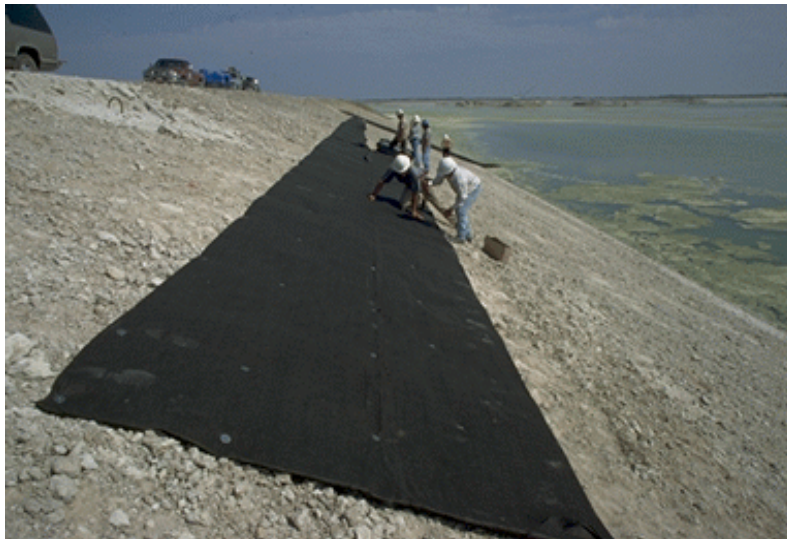
The prefabricated, plastic geodrain material comes in 4-foot wide rolls, 50 feet long. Installation consists of simply nailing the strips of geodrain to the upstream embankment, like giant shingles: see Figure 2. The nails are 18 inches long, with 1-inch washer-heads (i.e., pivoting): see Figures 3 and 4. The geodrain strips are overlapped a few inches, such that, like shingles, an upper strip overlies a lower strip: see Figure 5. The nails are driven on centers of 3 to 4 feet. With a little practice and common sense, it is a simple matter to unroll the strips one at a time and work downslope.

**Figure 2. Installation of Northern Geodrain Test Section.**  
Apr 05, 1999;  $t = -21$  days; Pond Level = 124.1 ft msl  
[04/12/99: 34]

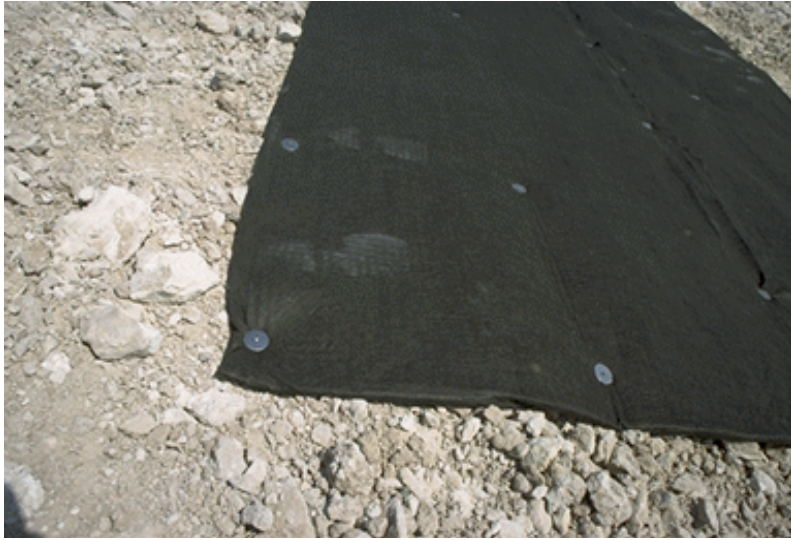
**Figure 3. Nailing Geodrain to Embankment.**  
Apr 05, 1999;  $t = -21$  days; Pond Level = 124.1 ft msl  
[04/12/99: 35]

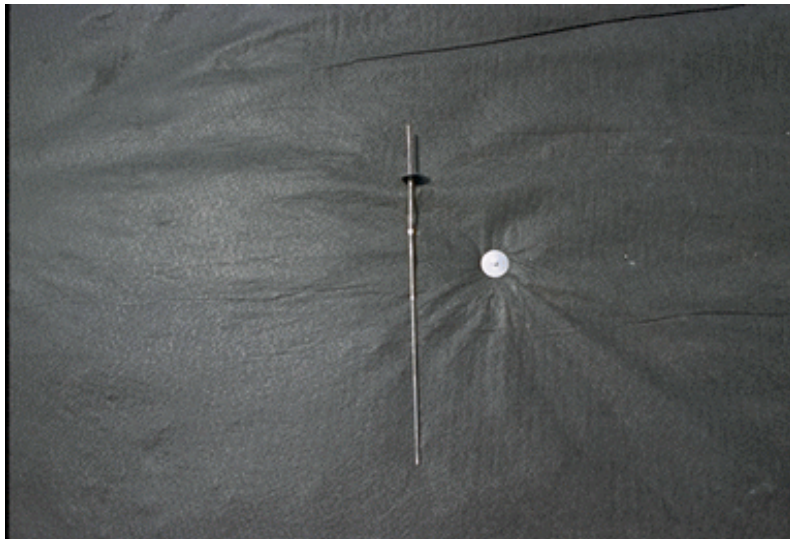
**Figure 4. Closeup of 18-inch Nail.**  
Apr 08, 1999;  $t = -18$  days; Pond Level = 124.5 ft msl  
[04/28/99: 2]

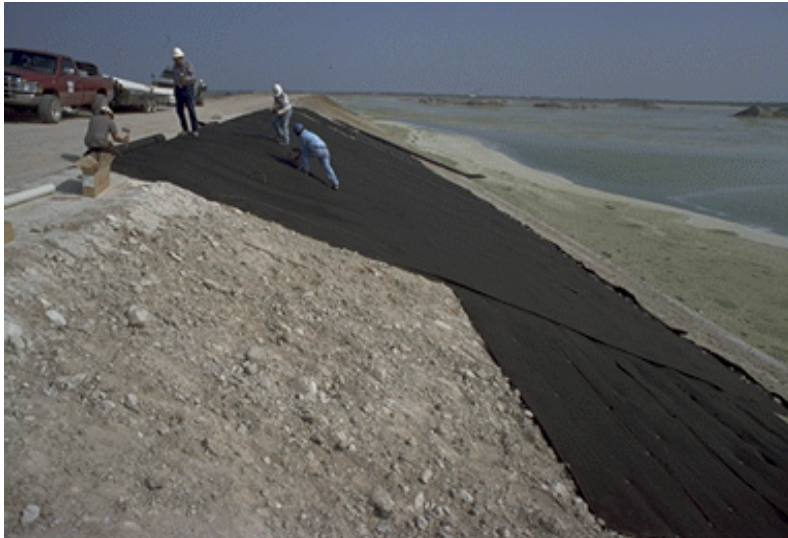
Each test section was further subdivided as follows: Two extra layers of geofabric were added to one 50-foot portion; one extra layer on another 50-foot portion; and no extra layer on another 50-foot portion: see Figure 6. The purpose of varying the thickness of geofabric was to determine if there were an effect on the clay dewatering capability and efficiency of the geodrain. In addition, geofabric was extended above the top edge of the geodrain to the crest of the embankment to help reduce erosion of the slope onto the geodrain.

**Figure 6. Installation of Additional Geofabric on Northern Geodrain Test Section.  
Apr 06, 1999;  $t = -20$  days; Pond Level = 124.4 ft msl  
[04/14/99: 3]**

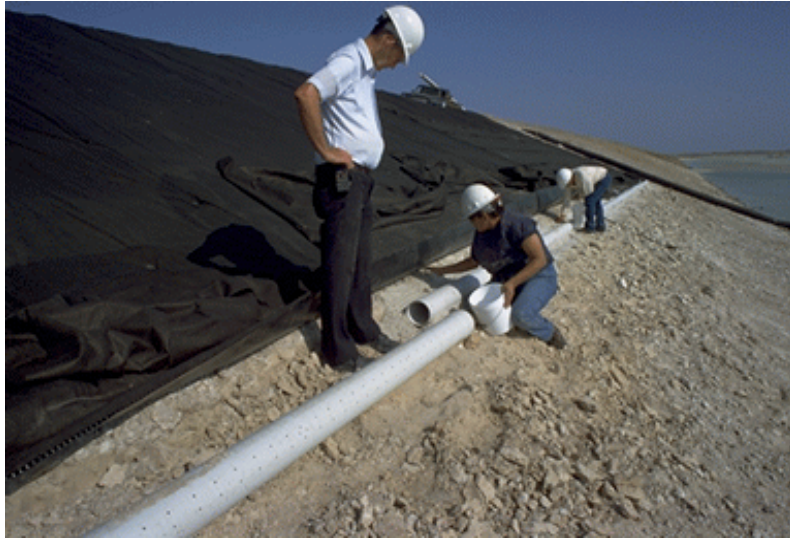
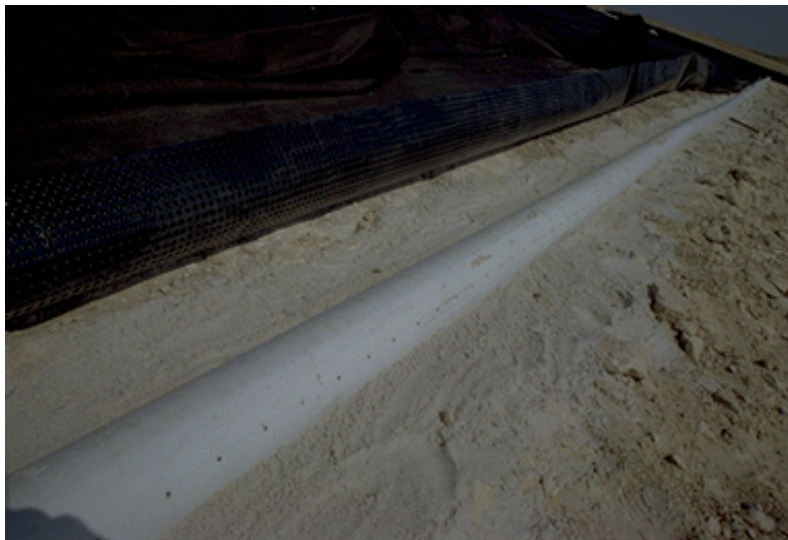
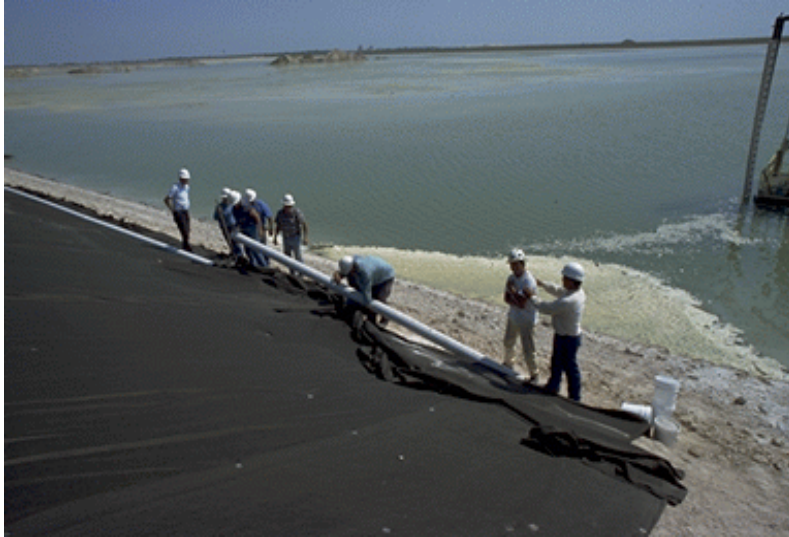
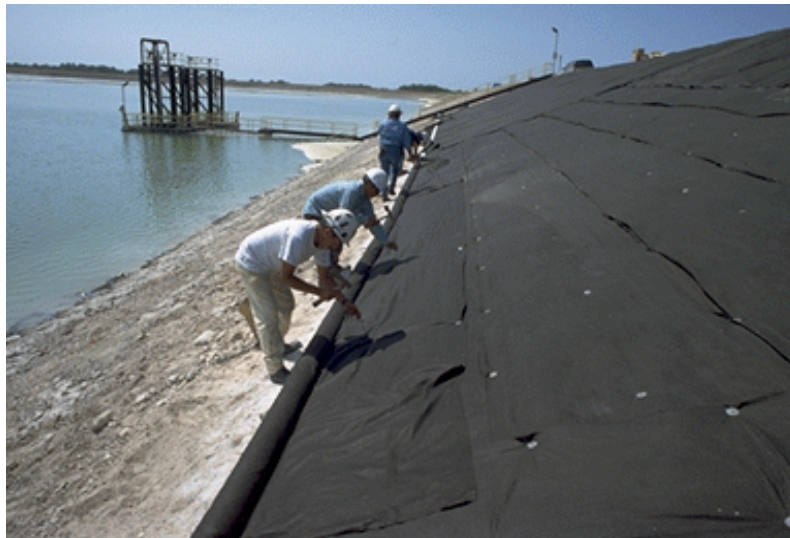
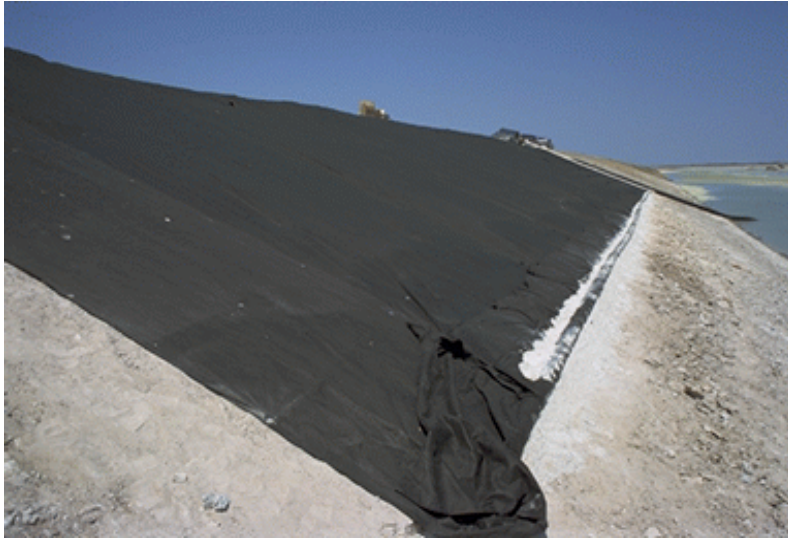
Next, a toe drain was installed along the bottom edge of each of the geodrain test sections. Each toe drain consisted of a 6-inch diameter, perforated PVC pipeline, placed in a shallow, shaped trench, wrapped with geofabric and covered with tailings sand: see Figures 7(a) to 7(e). The pipe comes in 20-foot sections, which were "glued" together with PVC solvent as assembly progressed. Specially welded anchors prepared by CF personnel were used to hold the toe drain in place: see Figure 8.

**Figure 7(a). Installation of Toe Drain for Northern Geodrain Test Section.**  
Apr 07, 1999;  $t = -19$  days; Pond Level = 124.4 ft msl  
[04/14/99: 15]

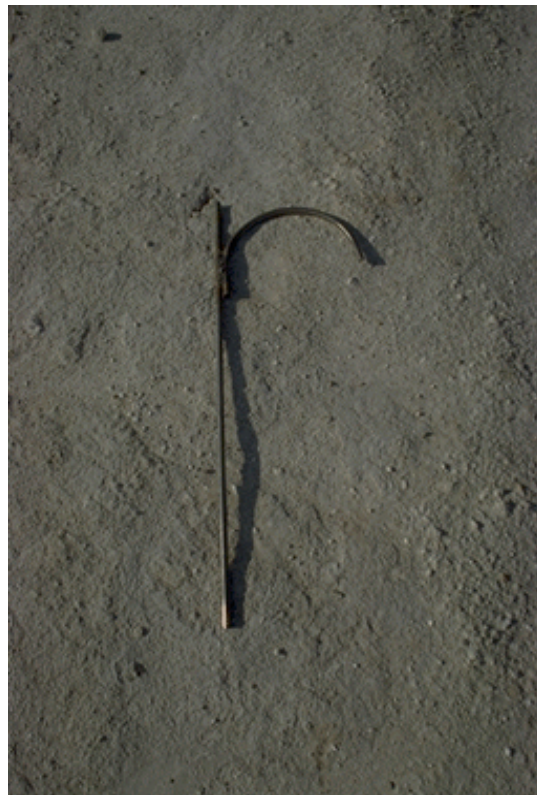
**Figure 8. Closeup of Welded Anchor Used to Hold Toe Drains and Conveyance  
Pipeline from Southern Geodrain Test Section.  
Apr 18, 1999; t = -8 days; Pond Level = 125.4 ft msl  
[04/28/99: 25]**

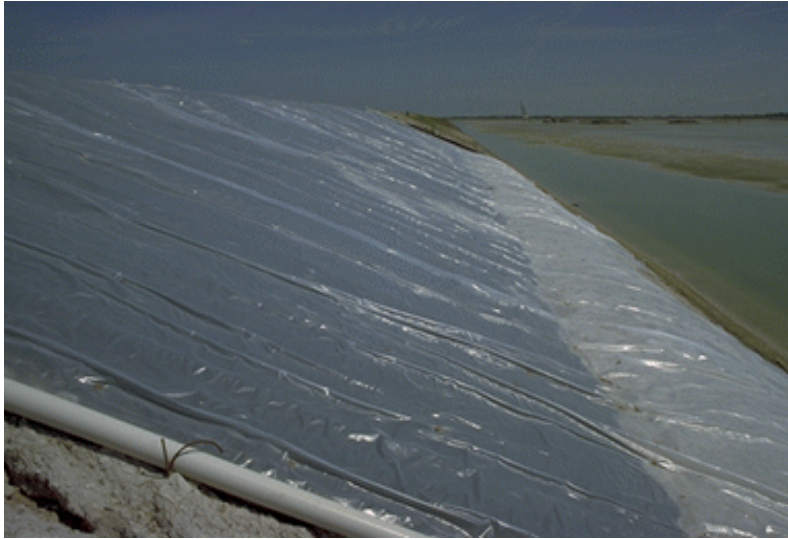
CF personnel placed additional tailings sand on the toe drain, and sheets of impervious polyethylene plastic were nailed over the geodrain and toe drain to protect the installation from runoff: see Figure 9. The plastic sheeting was intended as a temporary measure until the water level rose in the pond and covered the toe drain. At which point, the remaining plastic sheeting was going to be cut away and discarded, thereby re-exposing the geodrain.

The plastic sheeting-and-nail combination was found to be not well-resistant to wind, as the sheet tended to tear at the nails. (Plastic sheeting is commonly used to protect excavation slopes on construction sites, but the sheet is held down with sandbags.) Heroic efforts were made to hold the plastic sheeting together with duct tape. However, ultraviolet degradation occurred very rapidly and the sheeting virtually disappeared. Consequently, CF personnel placed additional tailings sand on the toe drain a second time, just before it was submerged by the rising pond water, and that sufficed: see Figure 10.

**Figure 9. Northern Geodrain Test Section: Additional Tailings Sand Placed on Toe Drain and Entire System Covered with Polyethylene Plastic Sheet.**  
May 28, 1999;  $t = +32$  days; Pond Level = 127.7 ft msl  
[06/21/99: 11]

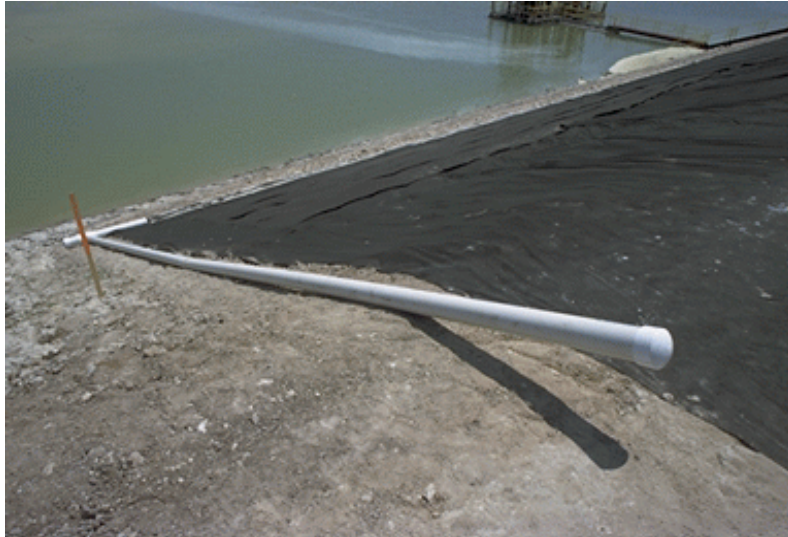
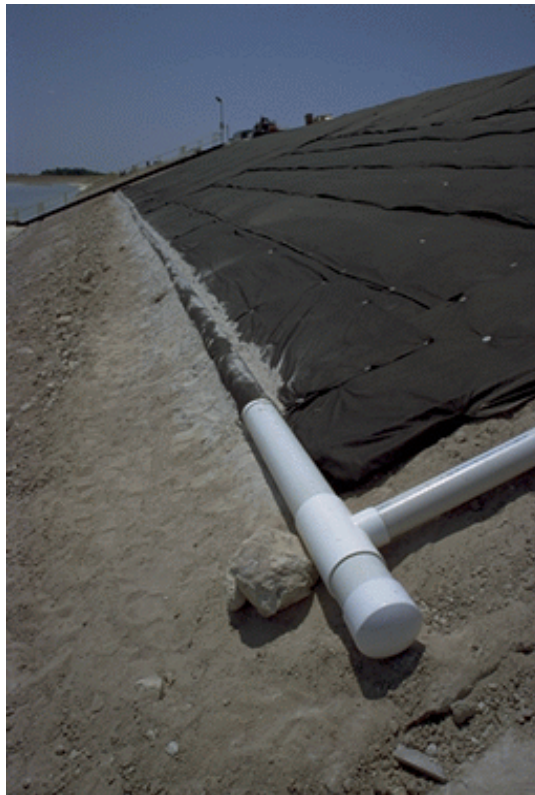
In order to monitor the water level within the toe drain, 4-inch diameter PVC riser pipes were installed at either end of each test section: see Figures 11(a) and 11(b). These pipes were simply glued to the toe drain pipe with a "T" section and laid up the embankment slope. A removable, press-fit cap was placed over the top end to facilitate access. The standpipes were numbered from the north end of the northern test section to the south end of the southern test section: N-1, N-2, S-1, and S-2, respectively. Once the toe drain was covered by the pond water, CF personnel recorded the water level in each standpipe on a weekly basis.

**Figure 11(a). Standpipe N-1 at North End of Northern Geodrain Test Section.  
Apr 07, 1999;  $t = -19$  days; Pond Level = 124.4 ft msl  
[04/14/99: 27]**

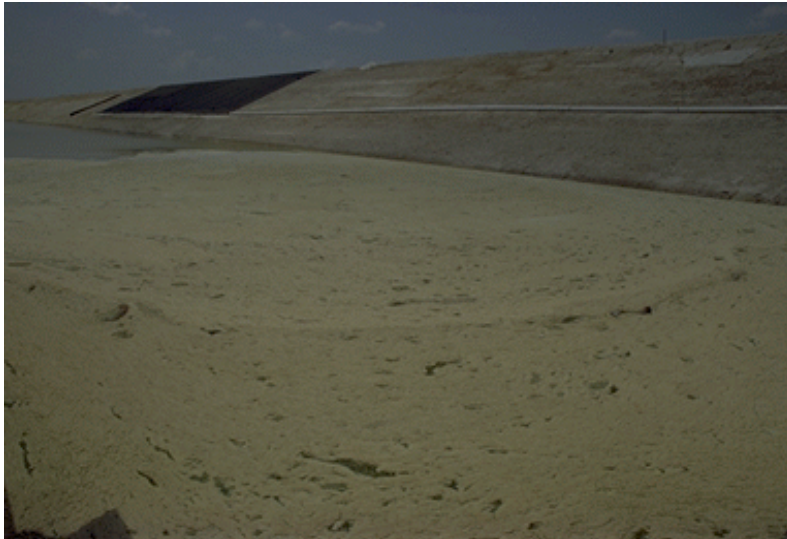
In order to convey the water from the toe drain in the southern geodrain test section to the spillway, it was necessary to assemble a 6-inch diameter PVC (non-perforated) pipe running north, longitudinally along the embankment, and under the catwalk: see Figure 12. This pipeline was held to the embankment with the same anchors that were used with the toe drains. Unfortunately, when the pond water rose, these anchors were found to be insufficient to resist the buoyancy of the pipeline and it floated: see Figure 13. It is believed that this pipeline failed, as water was never observed to flow from the southern test section into the spillway.

**Figure 12. Longitudinal Conveyance Pipeline from Southern Geodrain Test Section.**  
**Apr 26, 1999; t = 0 days; Pond Level = 125.8 ft msl**  
**[06/08/99: 15]**

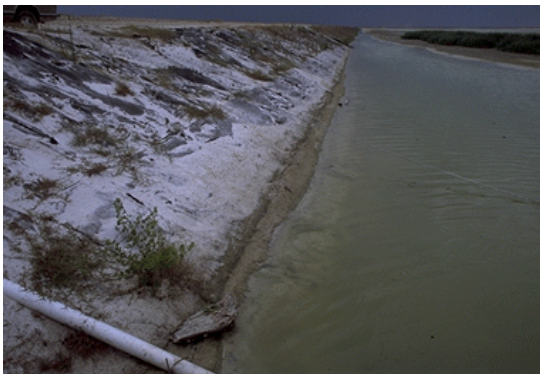
**Figure 23(bb). Jul 19, 2000; t = +450 days  
Pond Level = 137.0 ft msl [08/02/00: 35]**

As noted previously, the northern geodrain functioned from early May to late October 2000. In mid-July 2000, a “bulge” appeared in the natural pond drainage in front of the northern geodrain: see Figures 23(bb) and 23(cc). This phenomenon was (and is) attributed to a strengthening of the clay as a result of the geodrain. This bulging did not occur anywhere else in the vicinity of the spillway.

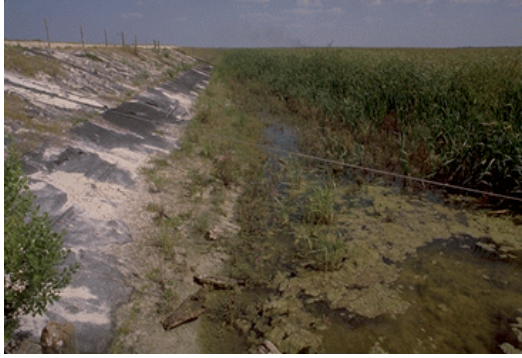
**Figure 23(ii). Mar 23, 2001; t = +697 days  
Pond Level = 136.0 ft msl [03/30/01: 24]**

At that time, the clay was bare. As the clay became vegetated, it was noticed that the vegetation in front of the northern geodrain looked “different”; compare Figures 23(ii) and 26(u), both taken on March 23, 2001. At the last site visit on July 3, 2001, it was observed that the vegetation in front of the northern geodrain consisted of: A strip of low grass next to the geodrain, about 5 feet wide; a strip of medium height herbaceous species, about 5 feet wide; and tall cattails beyond. The herbaceous strip did not occur south of the catwalk, nor north of the northern geodrain test section: compare Figures 23(mm) and 26(x).

Thus, even though a change in solids content has not been measured, the vane shear tests and the vegetation pattern indicates the geodrain has caused a beneficial change in the clay consistency.

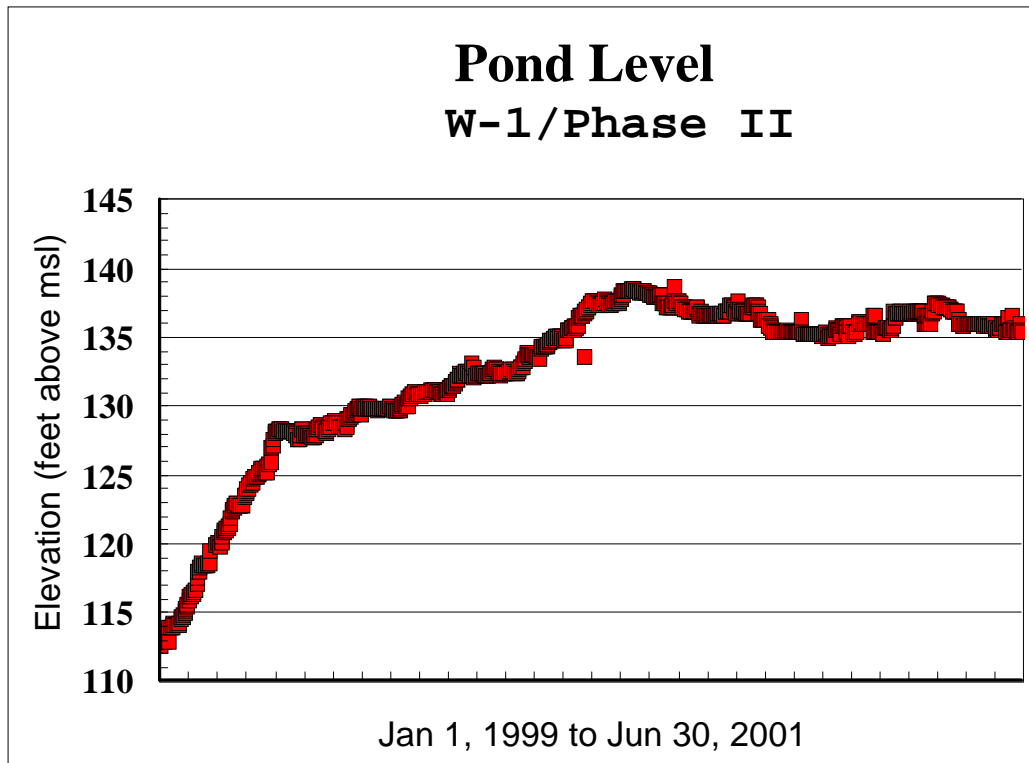
**Figure 28. Daily Pond Level.**

The daily pond level elevation of the W-1/Phase II disposal/reclamation area is shown in Figure 28, covering the period January 1, 1999 to June 30, 2001, or two-and-a-half years. This data was obtained from CF records and two or three datapoints appear to be erroneous. For example, on March 24, 2000, the level was recorded as 133.7 feet msl; whereas, the day before it was 136.7 feet msl, and the day after it was 136.8 feet msl. Thus, it is likely a transcription error was made and 133.7 should actually be 136.7. However, no attempt has been made to correct the data.

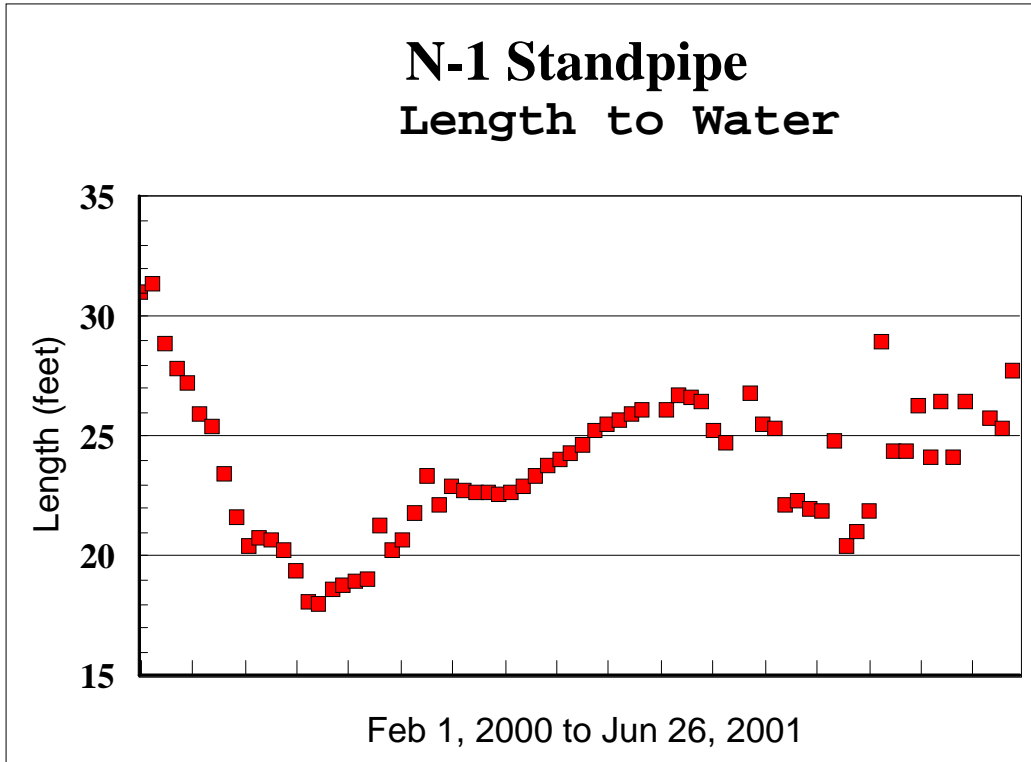
**Figure 29. Weekly Length to Water in N-1 Standpipe.**

In February 2000, the pond level rose above the toe drain in the geodrain test sections and CF personnel began measuring the length to water in each of the two standpipes located on either end of both geodrains. This continued on a weekly basis until the end of June 2001. The data for the N-1 standpipe, located at the north end of the northern geodrain, is shown in Figure 29. The early part of the record reflects the rising pond level (decreasing length to water) and can be used to establish a linear correlation between length to water in the standpipe vs. elevation of water in the standpipe. This has been done and the length data has been converted to elevation data. Then the elevation of the water in the standpipe can be compared with pond level elevation. This is shown in Figure 30, where the difference in elevation is plotted for the period May to October 2000, during which the northern geodrain was functioning. For much of this period, the pond level was higher than the standpipe, indicating a hydraulic flow from the clay to the geodrain and thence to the spillway. The maximum measured difference was approximately 0.7 feet. Toward the end of October 2000, the pond level was approximately 0.7 feet *below* the standpipe. It is believed that this occurred when the repaired elbow re-emerged above the clay surface (described previously), and water was actually trapped in the geodrain behind the layer of clay that had been deposited on it. Of course, water from the geodrain ceased flowing into the spillway at that time.

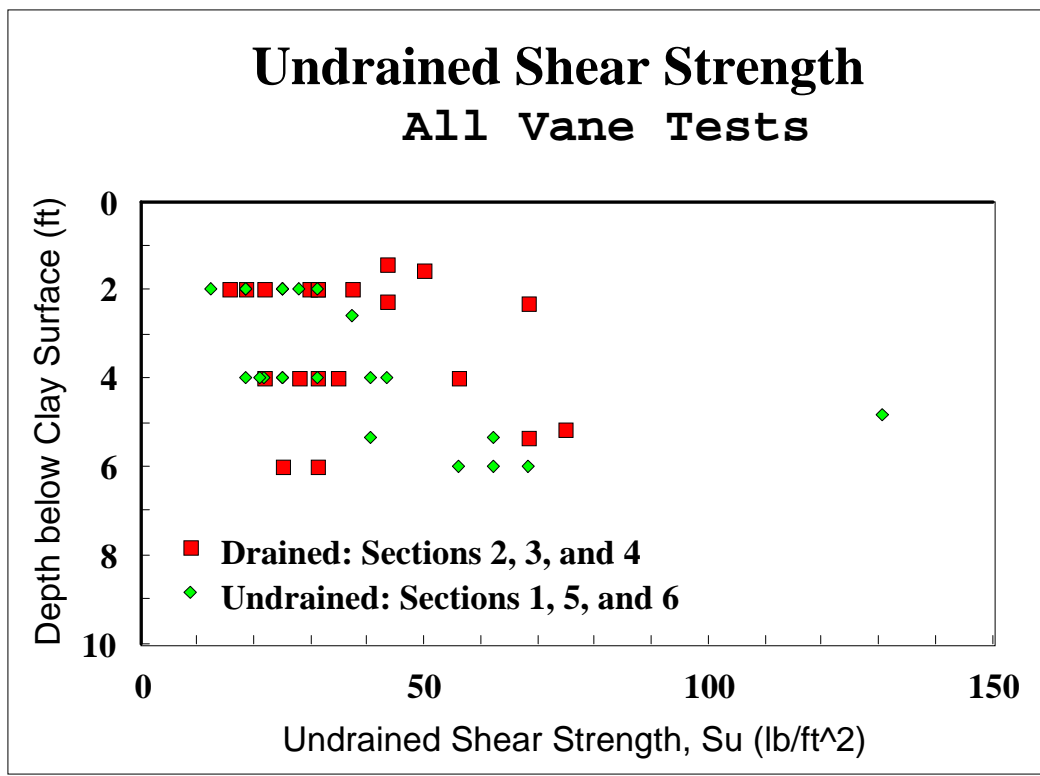
Figure 31. In Situ Vane Shear Strength of Clay.

The shear strength results are shown in Figure 31, where two different symbols have been used to distinguish between the drained sections (2, 3, and 4: in front of the northern geodrain) and the undrained sections (1, 5, and 6).

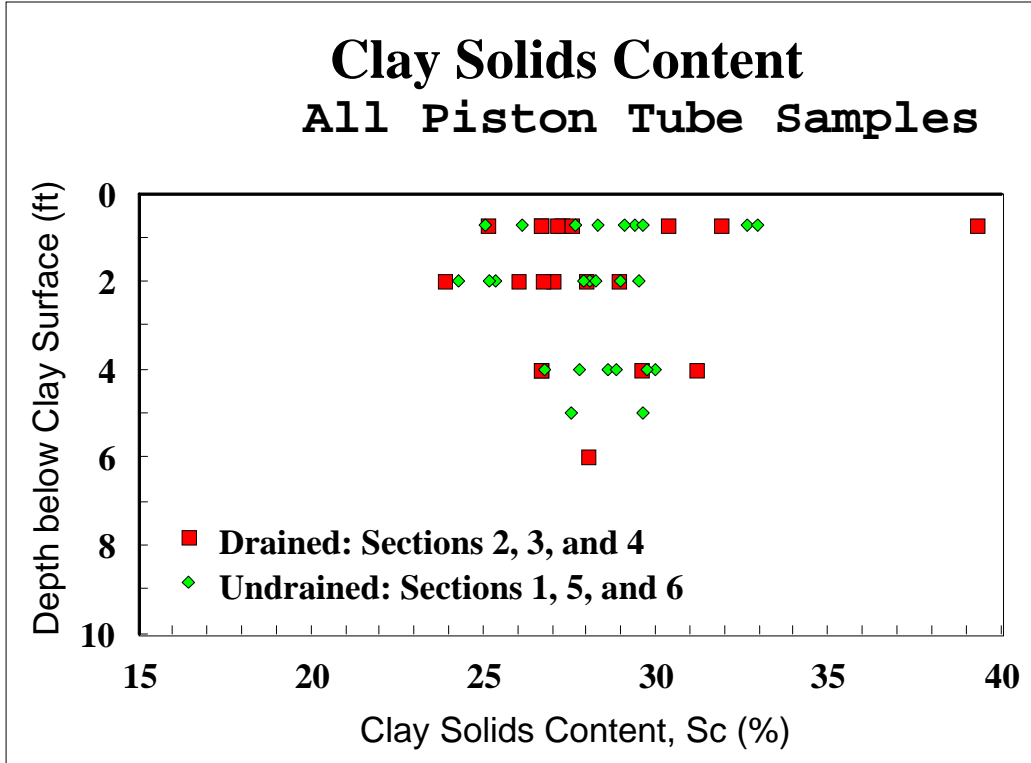
Figure 32. Clay Solids Contents from Piston Tube Samples.

For each of the piston tube samples that were recovered from area W-1/Phase II, the total solids content and the sand-clay ratio was measured in the laboratory. The clay solids content was then calculated with the preceding formula. The results are presented in Figure 32, where two different symbols have been used to distinguish between the drained sections and the undrained sections. In general, there was very little difference in the clay solids contents, both drained and undrained averaging about 28%.
