# PILOT PROJECT TO TEST NATURAL WATER TREATMENT CAPACITY OF WETLAND AND TAILING SAND FILTRATION ON MINED PHOSPHATE LANDS

# FINAL REPORT

Peter J. Schreuder, CPG Principal Investigator

> > March 2005

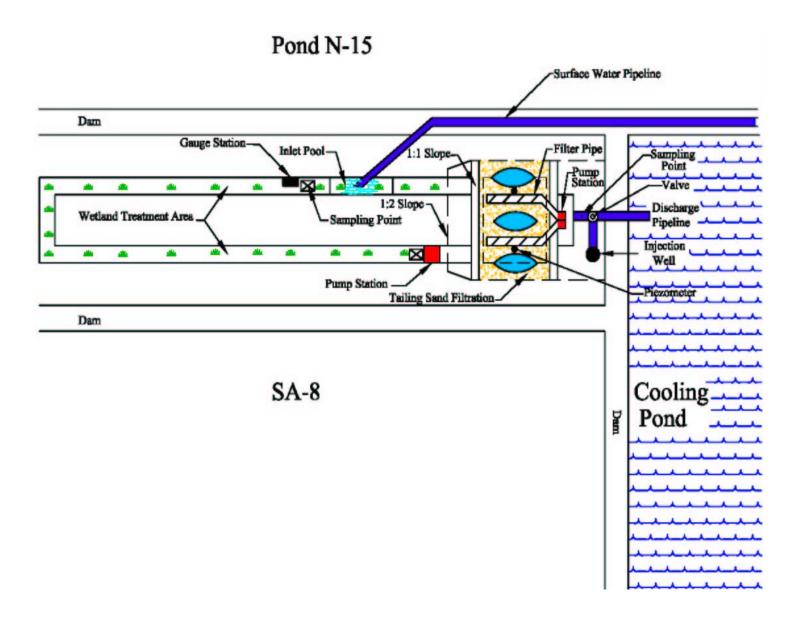
Figure 5. Original Concept of Pilot Project Set-Up.

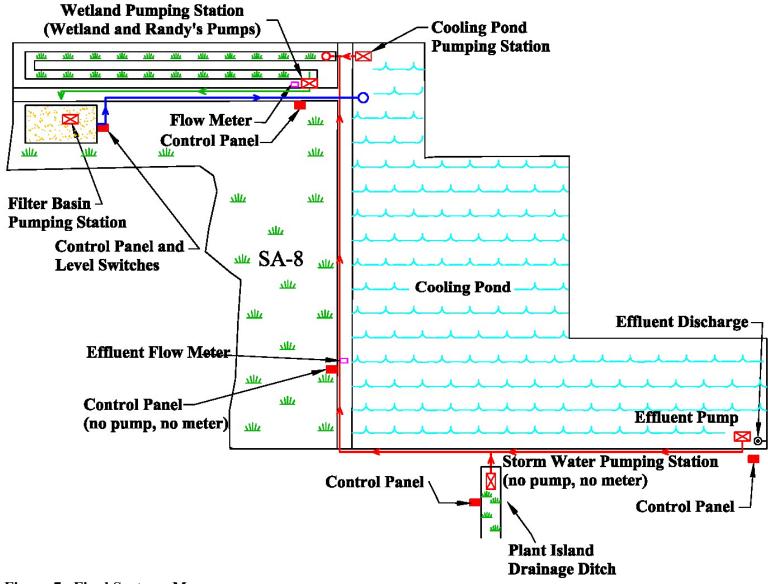
Figure 7. Final Systems Map.

The overall project configuration is shown in Figure 7. It consists of seven pumping stations: at the wetland, the basin, the cooling pond, the SA-8 CSA, the Plant Island drainage ditch, and at the effluent discharge pipe into the cooling pond. At each location, electrical power was provided by PEF to electrical panels, which were installed along with control systems. At the wetland, basin, cooling pond and effluent location, 7.5 HP electrically-driven centrifugal pumps, each with a 240-260 gallon per minute (gpm) capacity at 60-70 pounds per square inch (psi) total dynamic head were installed. In addition, continuously recording flow meters were installed. The water pumped from the cooling pond, SA-8, the Plant Island drainage ditch and Effluent Discharge pipe were all routed to discharge to the east side of the north ditch of the wetland through a 4-inch diameter HDPE pipe or larger. Similarly, the wetland pumping station was connected to the basin through a 4000 ft long 4-inch diameter HDPE pipeline. The water pumped from the basin was discharged to the cooling pond through a 4500 ft long 4-inch diameter HDPE pipeline.

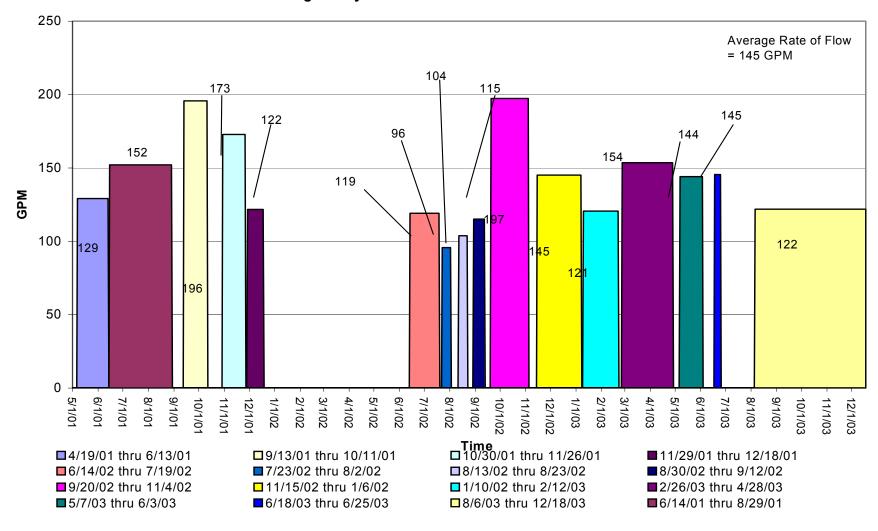
# Average Daily Flow out of the Filter Basin Over Time

Figure 8. Average Daily Pumping Rate from the Filter Basin.

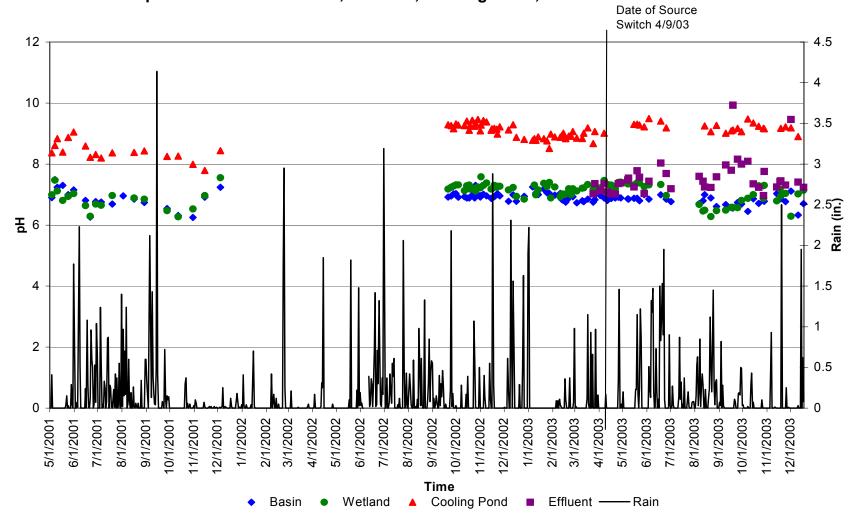
# pH vs. Rain in the Basin, Wetland, Cooling Pond, and Effluent over Time

Figure 9. pH and Rainfall Over Time.

Figure 9 shows the rainfall measured at the basin against time, along with the pH measurements at the wetland and the basin. It is interesting that the reduction of the pH does not seem to be greatly influenced by the rainfall, which totaled approximately 158 inches for the entire study period. This amounts to an input of 4.9 MG onto the total surface area of the filter basin.

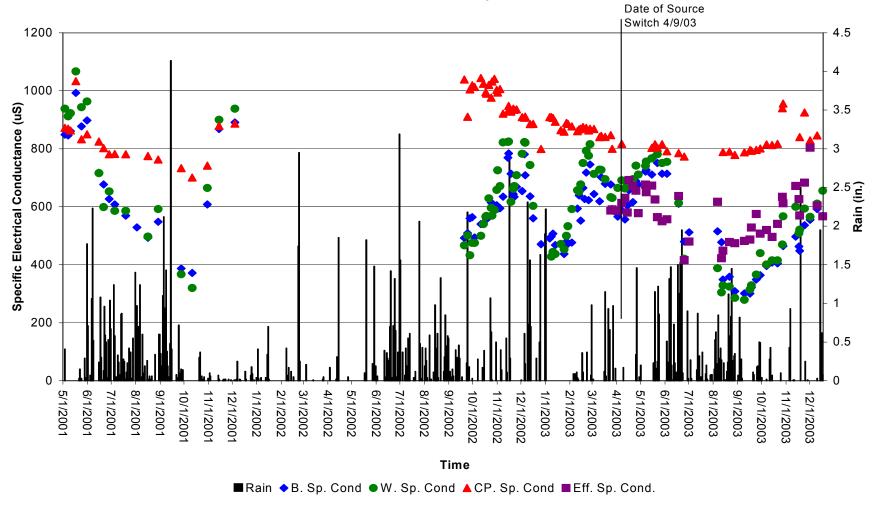
# Specific Electrical Conductance versus Rain in the Basin, Wetland, Cooling Pond, and Effluent over Time

Figure 10. Specific Electrical Conductance and Rain Over Time.

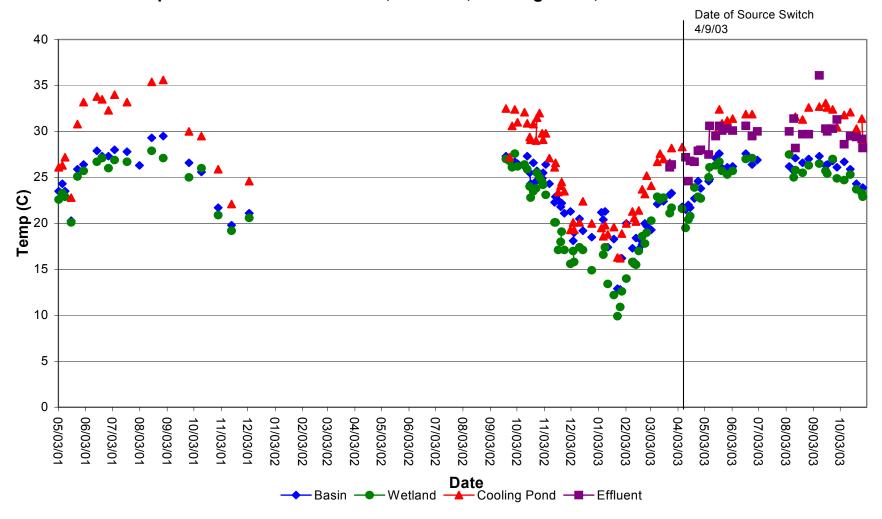
# Temperature in the Filter Basin, Wetland, Cooling Pond, and Effluent over Time

Figure 11. Temperature Over Time.

The recorded temperatures in the cooling pond, wetland basin and effluent station are presented graphically in Figure 11. The changes in season were reflected by the changes in the temperatures as seen in the same figure. The greatest seasonal change in temperature occurred in the water in the cooling pond declining from a high of 32.5°C on September 20, 2002 to a low of 16.2°C on January 27, 2003, a seasonal change of more than 16°C.

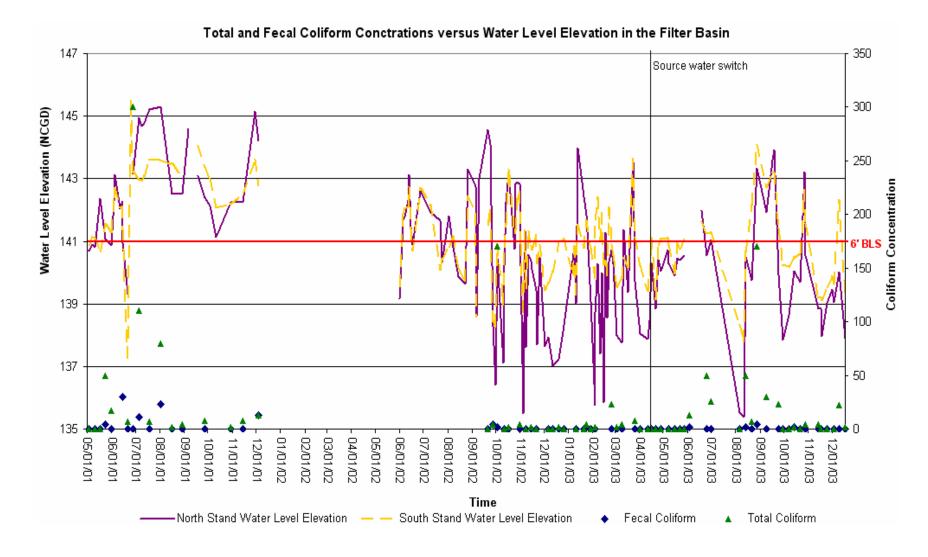
Figure 12. Water Levels in North and South Stand Pipes with Fecal and Total Coliform Concentrations.

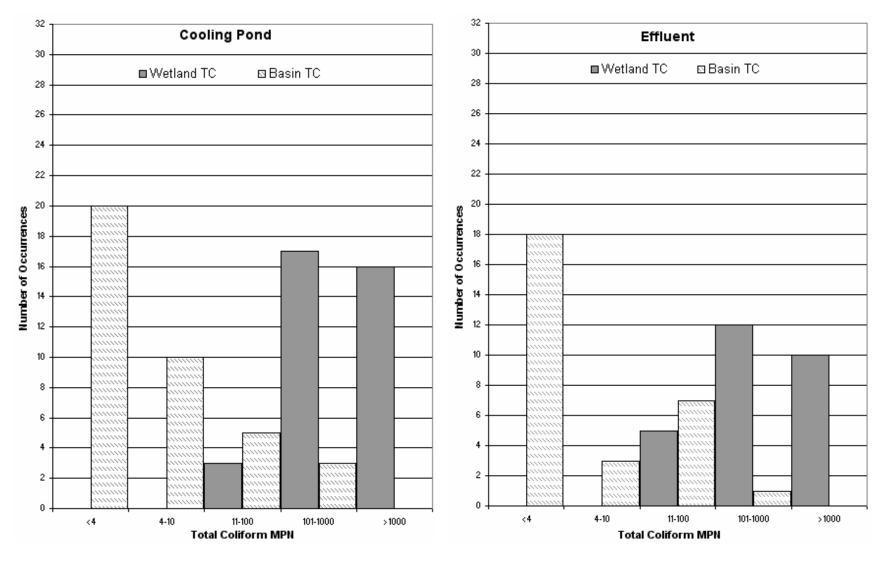
Figure 13. Total Coliform Frequency Distribution at Wetland and Filter Basin.

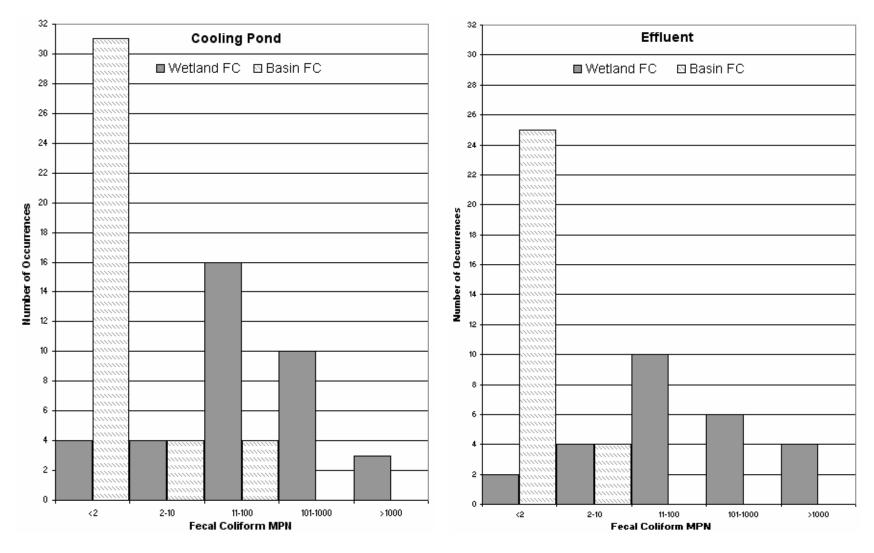
Figure 14. Fecal Coliform Frequency Distribution at Wetland and Filter Basin.

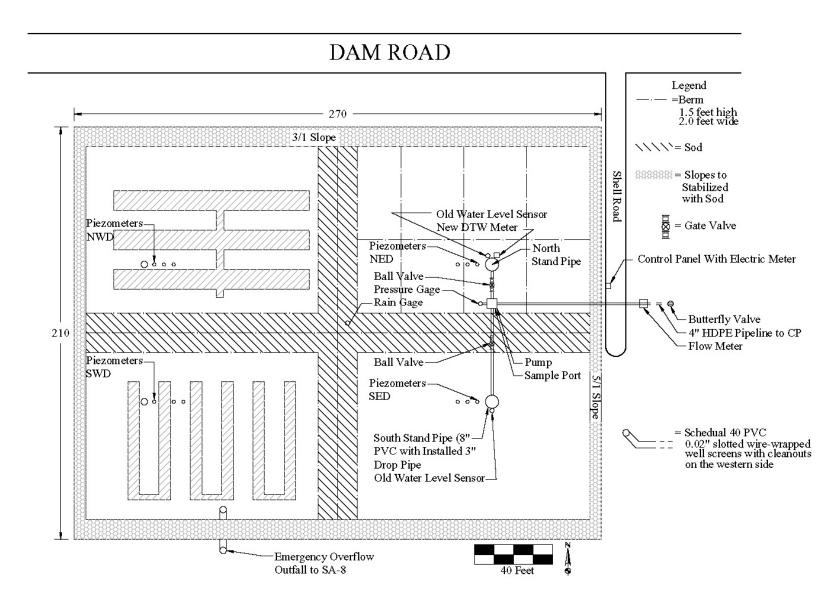
Figure B-1. Surface Dimensions of Tailing Sand Filter Basin and Constructed Surface Depressions for Different Percolation Patterns.

In September 2000, a 4-inch HDPE pipeline was installed to transfer the filtered water from basin back to the cooling pond. The return pipeline is located parallel to the wetland transfer line on the south side of the linear wetland. The pipeline from the basin to the cooling pond was buried under the service road to allow for vehicle access. To avoid any potential washout of the basin's dams resulting from a malfunction of the pumping system controls or excessively heavy rainfall, an emergency overflow outfall was constructed to the SA-8 clay settling area (CSA) in September 2000 as shown in Figure B-1.

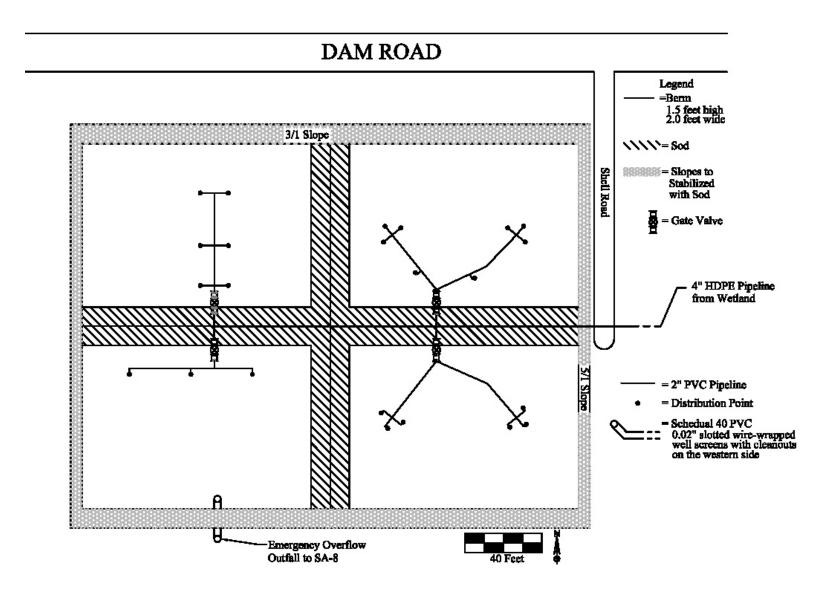
Figure B-2. Plan View of Distribution Points from the Wetland on the Filter Basin.

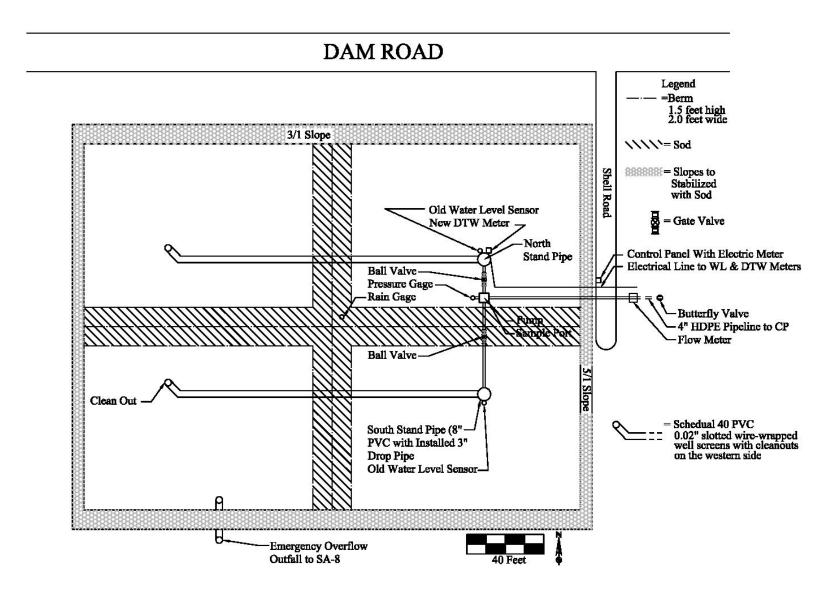
Figure B-3. Mechanical and Electrical Control System for the Filter Basin.

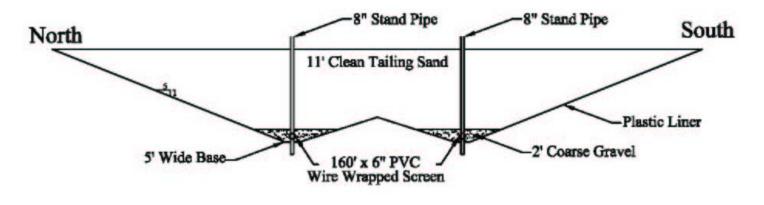
Figure B-4A. North/South View of the Filter Basin in Cross-Section.

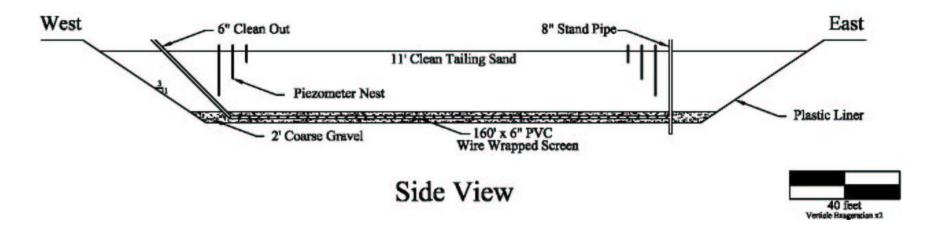
Figure B-4B. East/West View of the Filter Basin in Cross-Section.

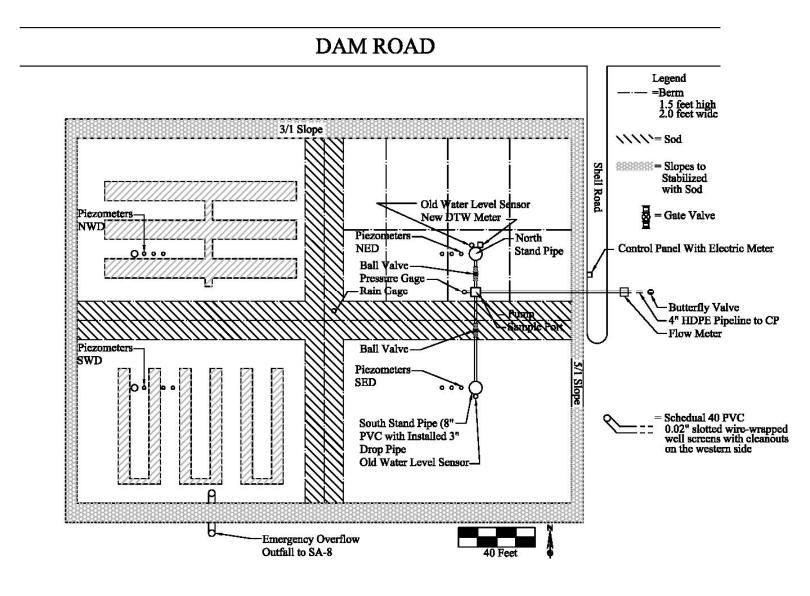
Figure B-5. Monitoring and Data Collection Points Map.

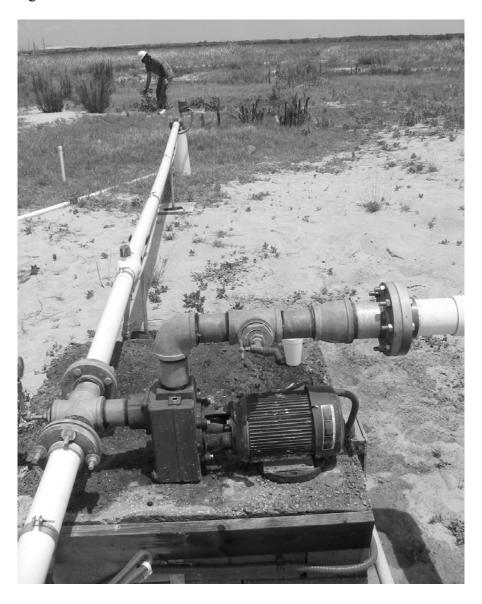
In December 2000, a pumping system, which consists of a 7.5 hp pump, was installed at the basin on a concrete pad in the center of the east side of the basin to withdraw filtered water from both 8-inch standpipes connected to the horizontal filter pipes as seen in Figure C-1. There are two ball valves on the PVC intake pipes to the basin pump. These valves control the removal of water from the basin and can force the separate withdrawal of water from only the north or only the south standpipe of the basin. A flow meter and a butterfly control valve were installed just on the east side of the service road. The butterfly valve can reduce or completely stop the amount of filtered water being pumped out of the basin. A service box was installed and power poles were relocated to the east side of the basin along with an electric meter. The electric utility is shown in Figure C-2.

Figure C-1. Tailing Sand Filter Basin Pumping Station.

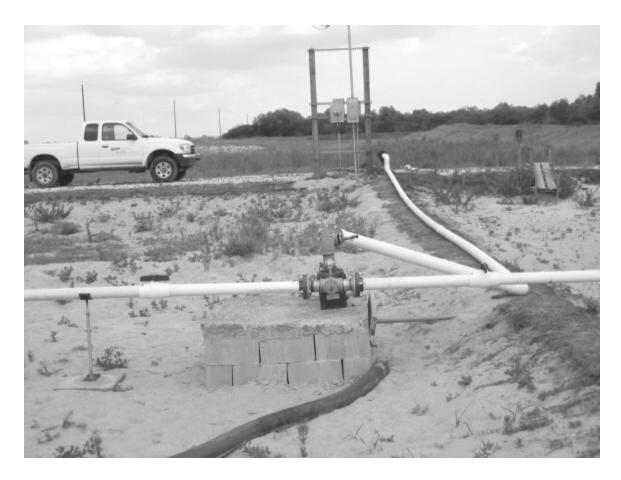
Figure C-2. Filter Basin Looking East Showing Electric Equipment.

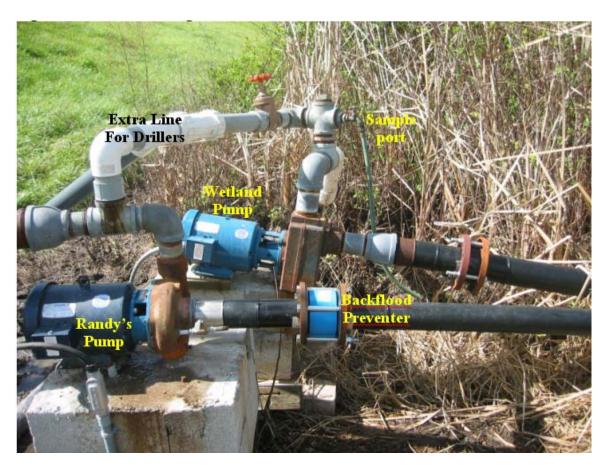
Figure C-3. Wetland System Pumping Station.

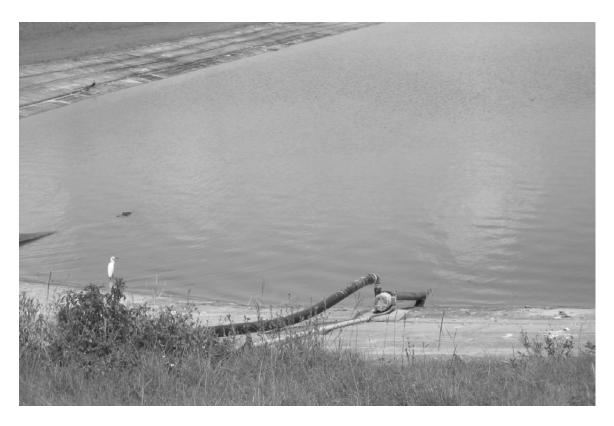
The cooling pond is a 722-acre cooling reservoir of the Hines power plant, which is surrounded by a soil concrete liner. The pumping station is placed on this soil cement base as shown in Figure C-4, along with an alligator to the left of the pump intake. A 7.5 hp pump was installed at the northwest corner of the cooling pond to continuously pump source water into the wetland.

Figure C-4. Cooling Pond Design.

As shown in Figure C-4, a 4-inch HDPE pipeline was installed to the cooling pond intake on the southwest corner along the south side of the cooling pond on the upper lip of the cement liner, which connects the effluent source to the existing 12-inch HDPE line that discharges into the linear wetland system. The pipeline was secured by drilling coated rebar into the cement liner. Orange safety caps were placed on the top of each rebar. Where the 4-inch effluent line crosses the cooling pond intake structure, metal brackets were fabricated to suspend the effluent line along the top of the sheet piling. This was completed in February of 2001. The effluent line was connected to the SA-8 supply line with a Y-fitting, and the resultant single line was run through a flow meter prior to attaching it to the existing 12-inch line through a saddle tap. A butterfly valve was installed in the 4-inch line to prevent back-flow when the high-volume SA-8 pumps are used, and back-flow preventer valves were installed on both the effluent and SA-8 supply lines. A flow meter was installed before the back-flow preventers on the effluent supply lines in July of 2003.

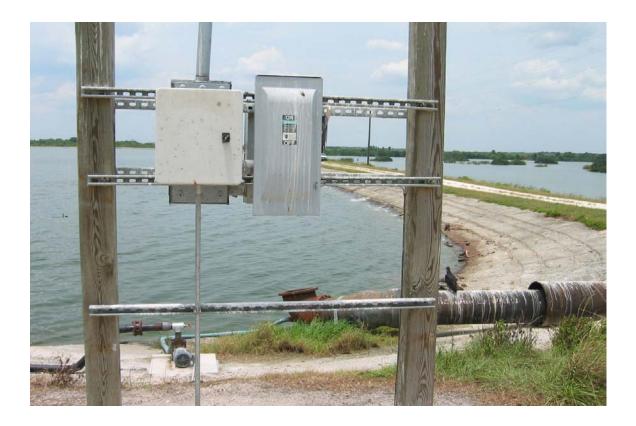
In December of 2000, a pumping station consisting of a 7.5 hp pump was installed at the Bartow effluent discharge location on the southeast corner of the cooling pond as seen in Figure C-5. This pump was connected to the 24-inch discharge line, which discharges treated effluent (domestic wastewater) directly into the cooling pond to replace any evaporative loss. A 90-degree flanged elbow was fitted to the existing effluent line to discharge the effluent vertically, providing a standing head of water in the effluent line when effluent delivery is interrupted or reduced.

Figure C-5. Effluent Design.

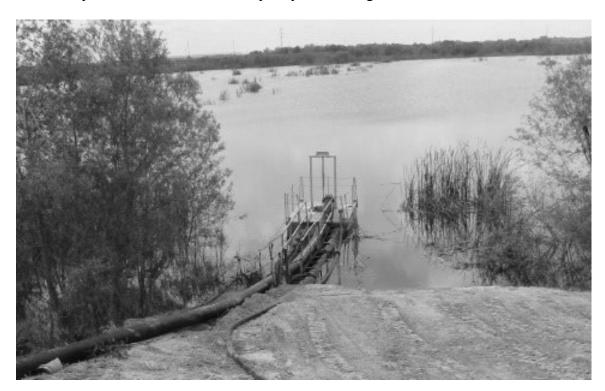
In December of 2000, a control panel was constructed at the SA-8, and electricity was run to the control panel. In February 2001, a pumping station, which consisted of a 7.5 hp pump, was installed with a mounting plate to the existing float that supports the high-volume SA-8 pump (see Figure C-6). A floating intake was fabricated and placed in readiness for pumping from SA-8. During the course of the 2000-2001 drought, water levels in SA-8 declined significantly. The shallow water conditions in SA-8 required the implementation of a back-up storm water source from the Plant Island storm water Retention Area and the SA-8 pump was relocated to the Plant Island Storm water drainage ditch. The connections and mounting plates for the pump were retained at SA-8 for later use, as water levels were expected to return to operable depths in the future. SA-8 is the preferred storm water source, as run-off from the plant island during the rainy season may warrant additional water quality monitoring.

Figure C-6. SA-8 Pumping Station.

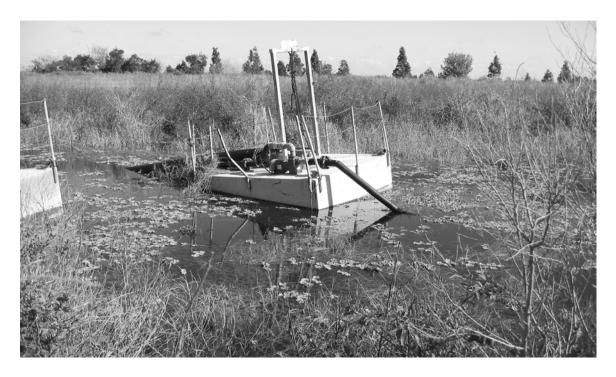
The Plant Island storm water ditch contains water in near equilibrium with other storm water sources on the site. As stated previously, a back-up source of storm water was established at the north end of the Plant Island storm water drainage ditch, which is located south of the cooling pond and east of the office building at Hines (see Figure C-7). In February of 2001, the storm water supply pump from SA-8 was moved to the existing float in the Plant Island ditch, and a 4-inch HDPE line was installed to connect this pump to the effluent supply line. Backflow preventer valves were installed in both lines. The source of storm water may be shifted back to SA-8 by simply disconnecting and moving the pump and float to the mounting plate on the SA-8 float.

Figure C-7. Plant Island Stormwater Drainage Ditch Pumping Station.

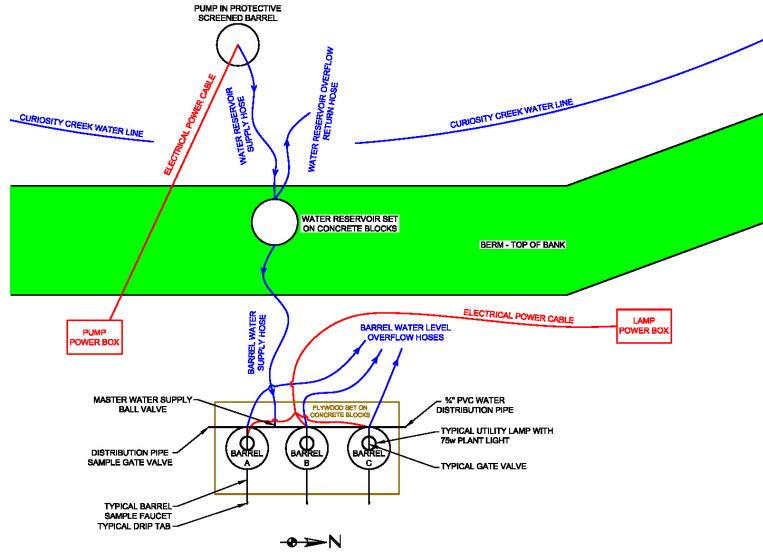
Figure J-1. Top View of Barrel Test Set-Up.

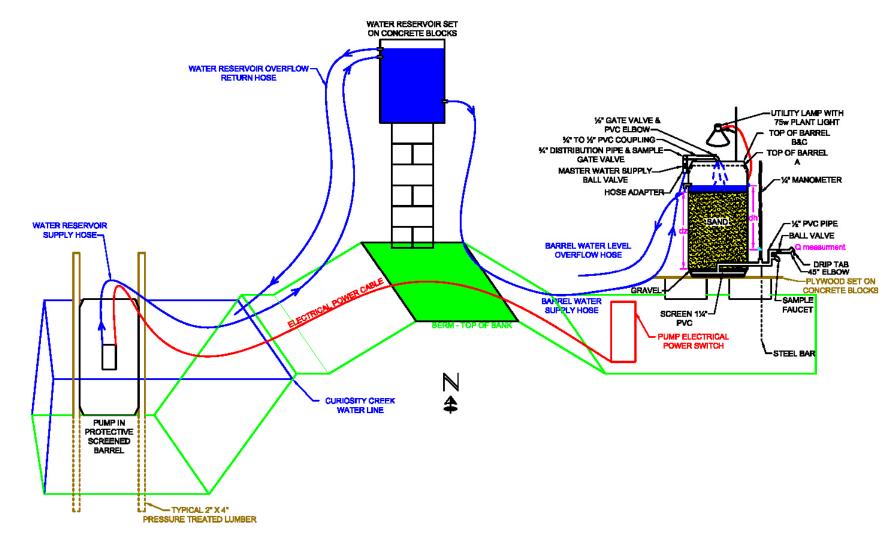
Figure J-2. Side View of Barrel Test Set-Up.

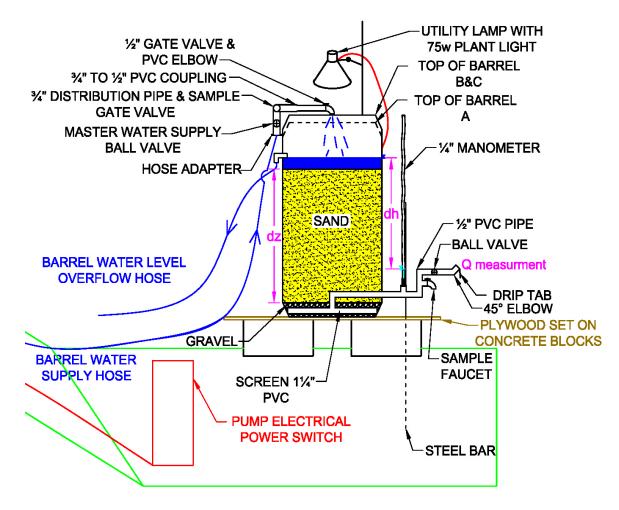
Figure J-3. Close-Up View of Barrel Test Set-Up.

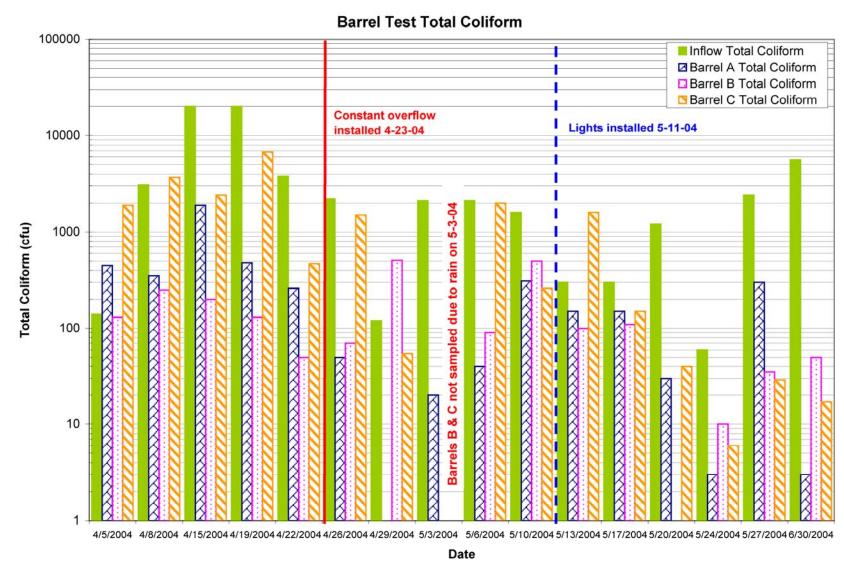
Figure J-6. Barrel Test Total Coliform Results.

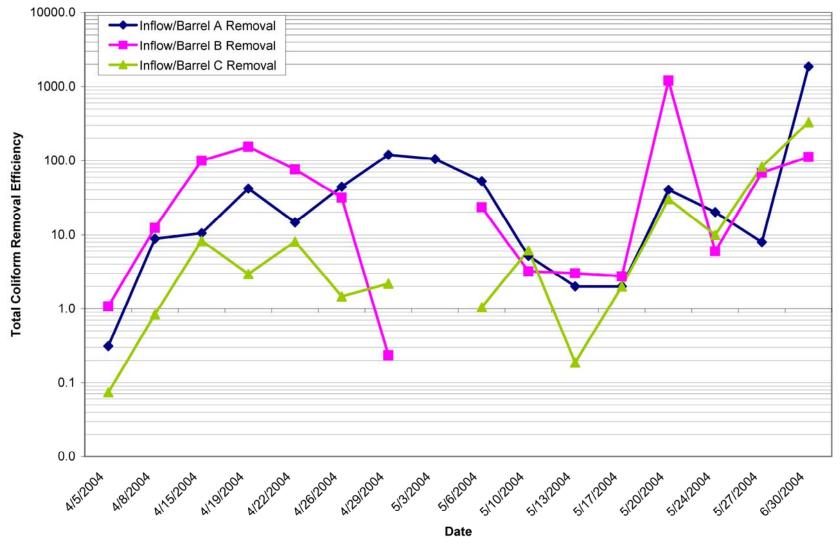
Figure J-7. Removal Efficiency of Inflow with All Barrels.

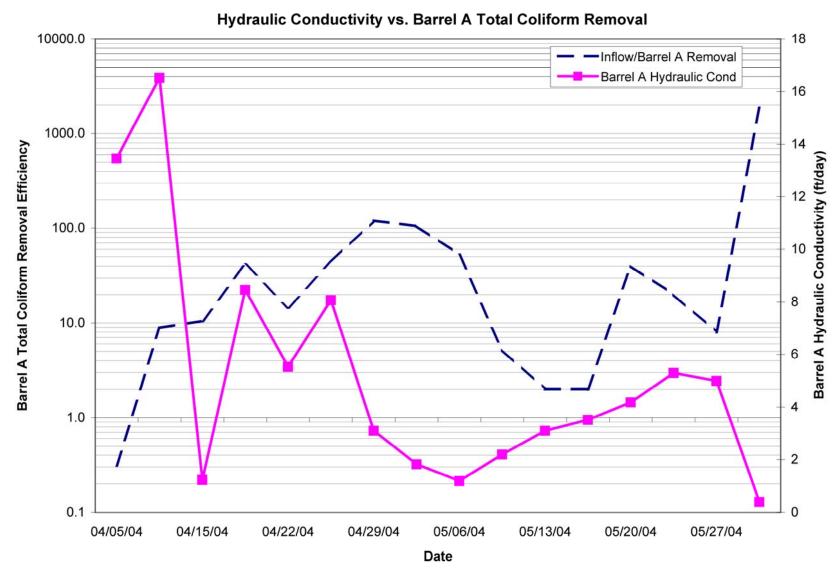
Figure J-8. Removal Efficiency of Barrel A with Hydraulic Conductivity.

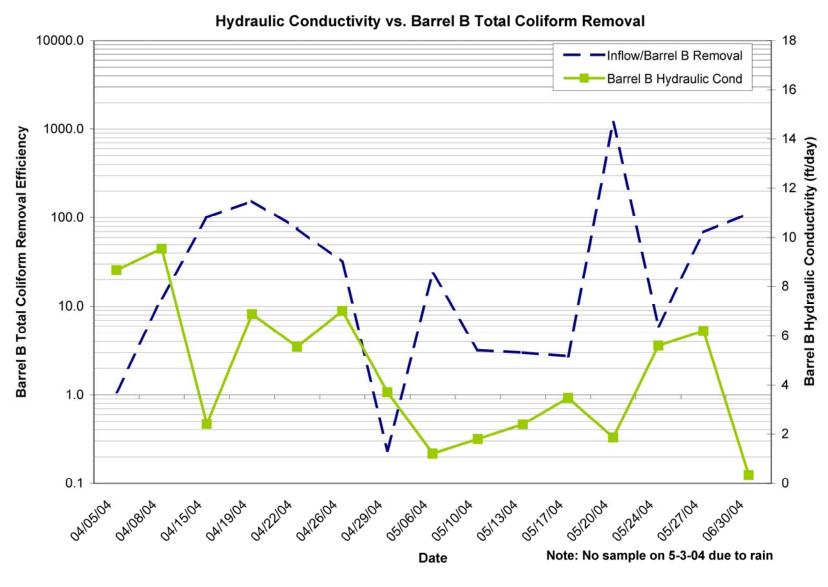
Figure J-9. Removal Efficiency of Barrel B with Hydraulic Conductivity.

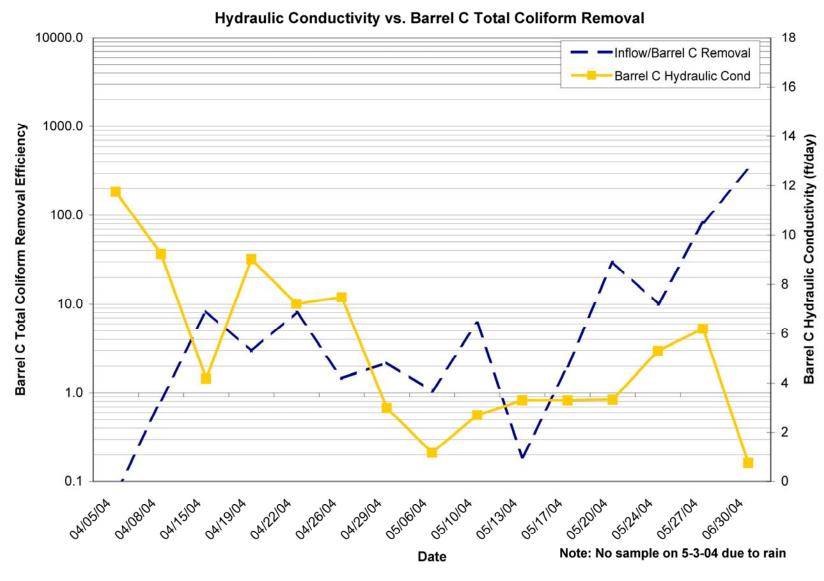
Figure J-10. Removal Efficiency of Barrel C with Hydraulic Conductivity.

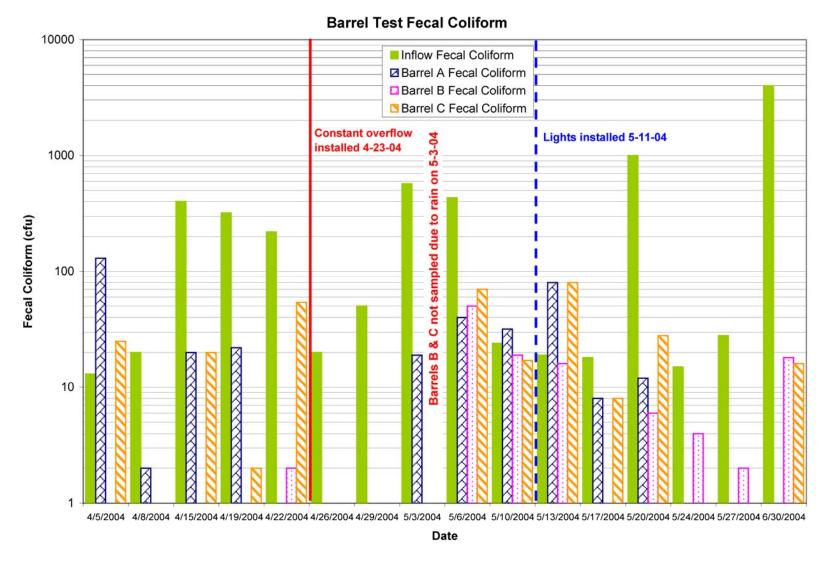
Figure J-11. Barrel Test Fecal Coliform Results.

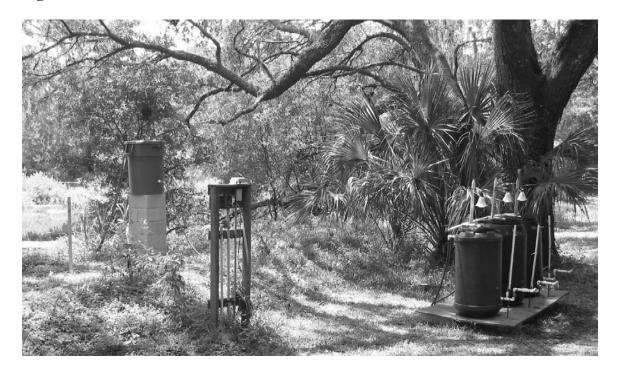
Figure J-13. Far Side View of Barrels Showing Reservoir and Electric Set-Up.
